Maintenance Program and New Materials on Boeing Commercial Aircraft

**Joseph H. Osborne
The Boeing Company
Seattle, WA**

13. SUPPLEMENTARY NOTES Surface Finishing and Repair Issues for Sustaining New Military Aircraft Workshop, February 26-28, 2008, Tempe, AZ. Sponsored by SERDP/ESTCP.

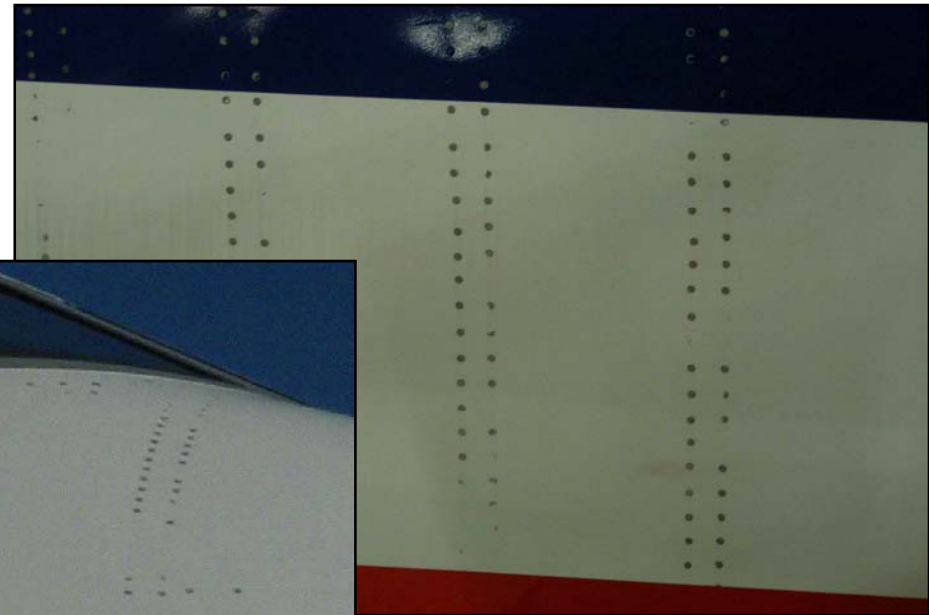
Performance Driver - Rivet Rash Reduction

Paint delaminates from rivets but not fuselage skins

- Affects all models and decorative paint systems
- Conventional conversion coating identified as contributing factor

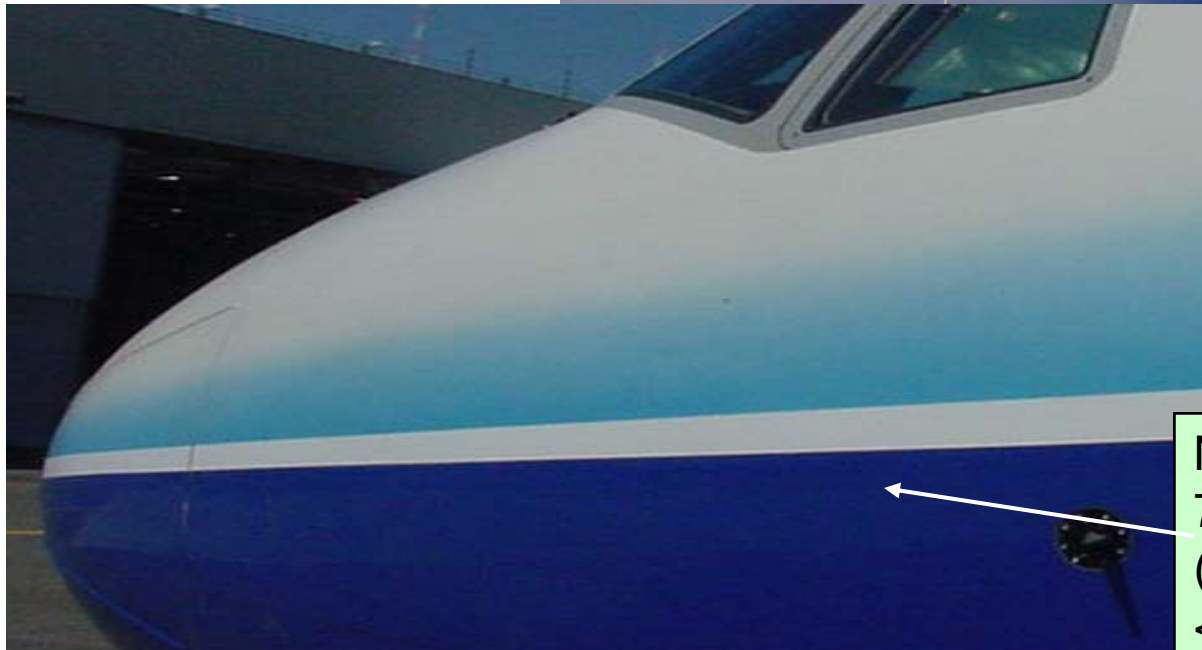
No Rivet Rash on 2nd
777-200LR
(**AC131-CB / Boegel EPII**)
<400 Flight Hours

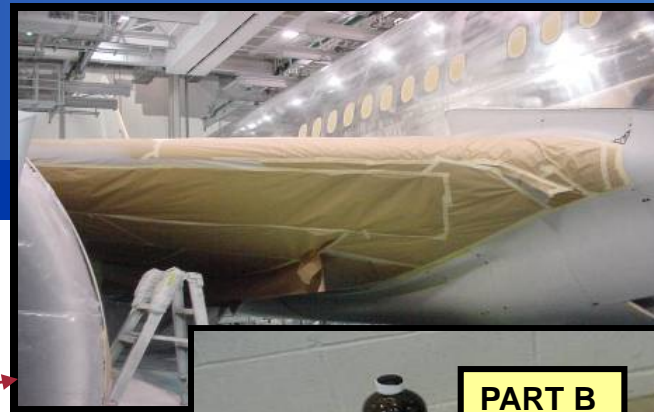
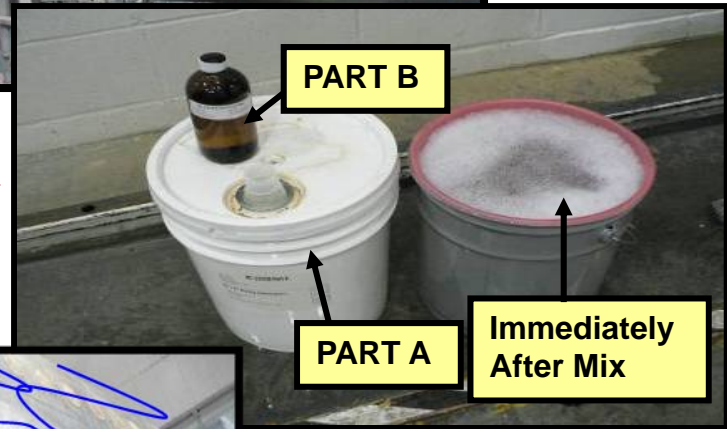
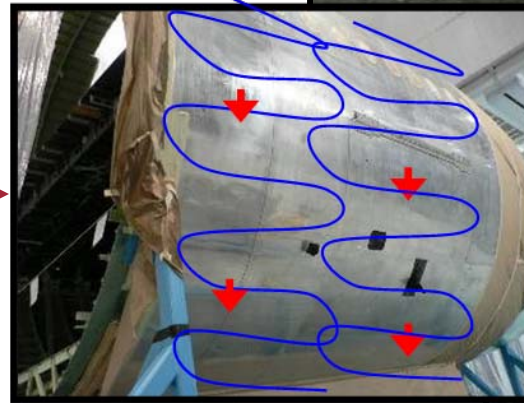
Process Optimization

- Solvent clean
- Deoxidize (chemical or mechanical)
- Water break free check
- Mask for Prime

1. Mix 2-part kit & shake 5 Min
2. 30 minute induction time
3. 24 hour pot life
4. Apply with air-assisted airless paint gun with small fluid tip
5. Spray top down
6. Apply minimum amount to wet surface
7. Allow 10 minutes drip
8. Wipe off excess, if necessary
9. Tape after dry, 1 hour min

- Complete mask for prime

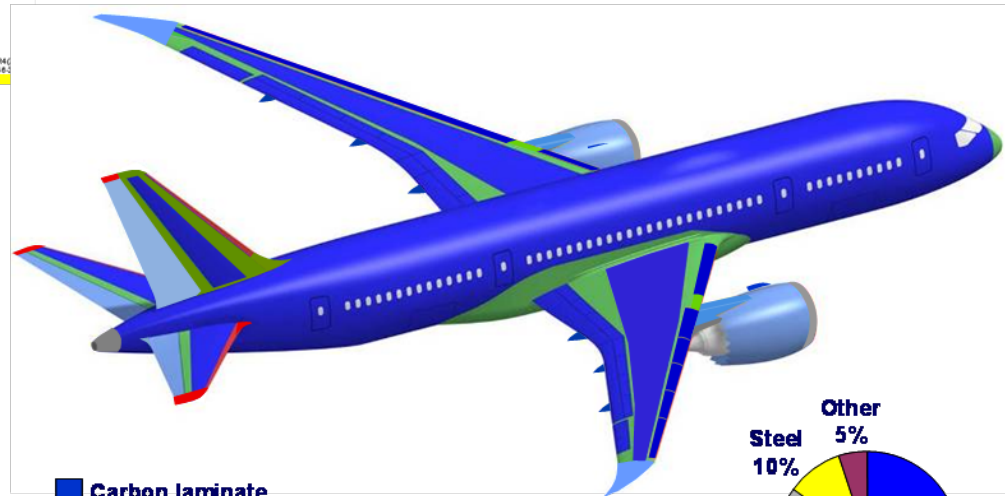
787 Composite Primary Structure

- Carbon laminate
- Carbon sandwich
- Other composites
- Aluminum
- Titanium

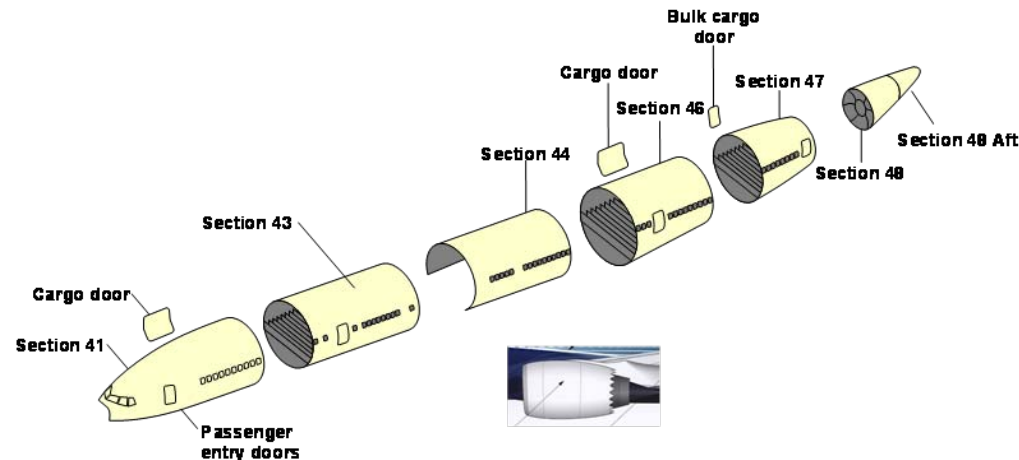
Substrates Approved for Chemical Stripping

During repaint, a thin layer of primer, the intermediate coat and the decorative paint is applied

Decorative colors (BMS10-125)
Intermediate coating (BMS10-120)
Exterior primer (BMS10-118)
Co-cured surfacing film (BMS8-341)
Graphite Skin (BMS8-276)

Over time, the paint stripper swells and delaminates the BMS10-120 intermediate coat from the BMS10-118 primer, removing the topcoat and most of the intermediate coat
